EXTERIOR REHABILITATION AND HOUSE PARTS

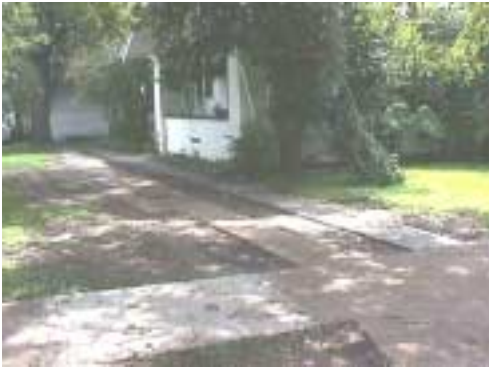
A concrete tire path driveway is a good alternative to solid paving.

- Driveways often have concrete strips, ribbons or tire paths.
- Tire paths or ribbons are recommended as an alternative to dirt or a solid surface on the driveway area and cost less than a solid concrete driveway.
- Other acceptable applications would be the installation of a hard edge, such as metal, filled with decomposed granite, pea gravel or asphalt.

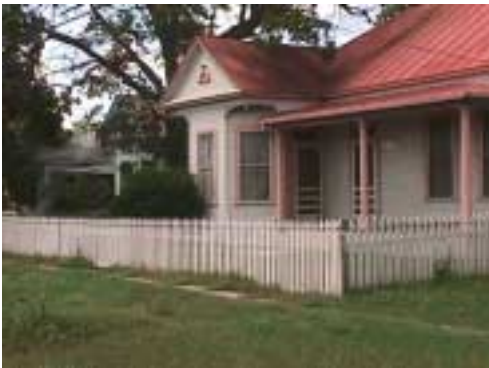
Wood picket fences should be restored.

- Front yards are often fenced, some with wood picket and others with chain link.
- Wood fences should be maintained and repaired.
- Chain link is not a historically appropriate fencing material for Government Hill. However, fence replacement is always voluntary.
- Garden loop wire or welded “hog wire” is more appropriate than chain link, especially for front yards. (Please note that City code allows a maximum height of four feet for a front yard link or wire fence and six feet for side and rear yards.)

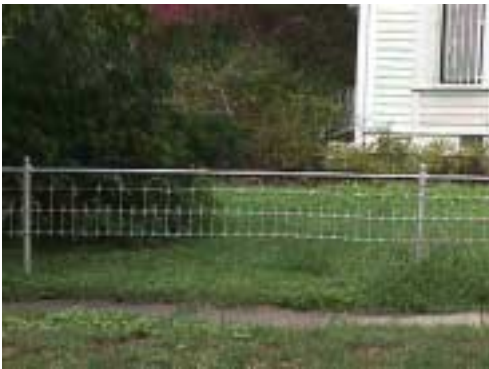
Or use wire fences

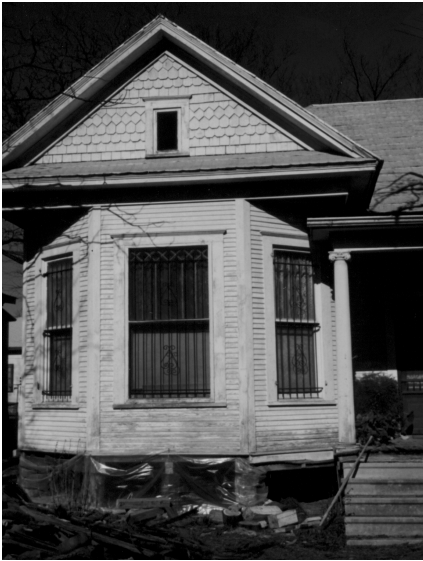
Cedar post foundations are common to wood frame structures.

The majority of houses in the Government Hill Historic District are wood frame construction with cedar post foundations set into the ground. This type of construction raises the house above the ground and the space between house and ground is closed in with a wood “skirt”.

The cedar posts have a tendency to weaken over time causing the house to shift. The skirts also deteriorate eventually. The best method to repair the foundation is to install new cedar posts or chemically treated wood. This allows for leveling of floors and the addition of extra supports, if needed.

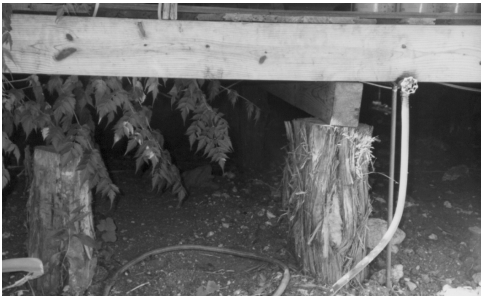
Pier and beam construction can be repaired with new wood members.

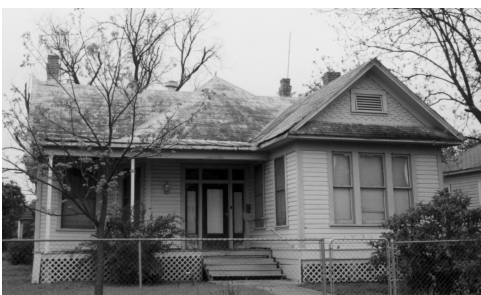
Lattice skirts allow for ventilation.

The skirting has a major visual impact on the structure. It anchors the structure to the ground and may have been lattice of a distinctive vertical and horizontal pattern. Ideally, the skirting should be maintained if possible, or remade to match the original in design and material. Chemically treated 2x4’s can be ripped into thin strips and used to create a new durable lattice. If wood rot is a concern, consider PVC lattice as a durable alternative to maintain historic appearance. Skirts of solid materials such as cement board siding or stucco are discouraged as a first choice because it changes the historic appearance and does not provide the essential ventilation of pier and beam foundations.

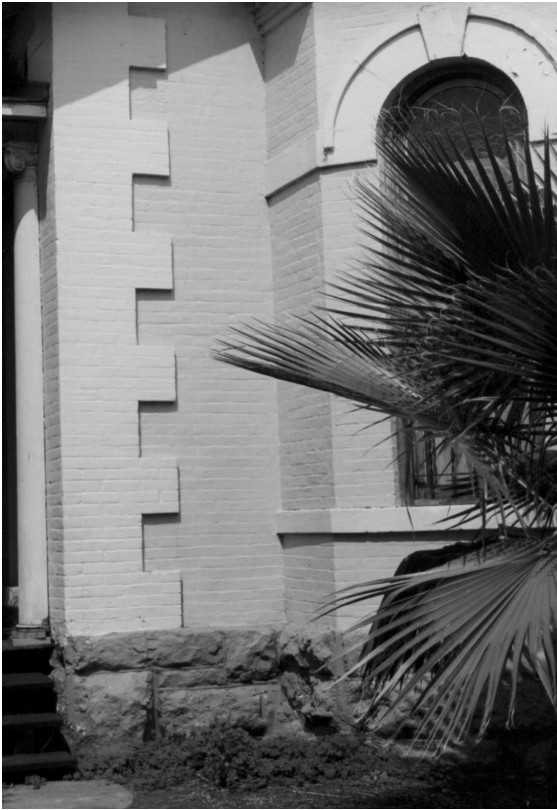
Stone perimeter beams or foundations last well over a hundred years if well maintained.

A few brick or stone structures with brick perimeter beams and interior supports are found in the neighborhood. Brick foundations may have deteriorated mortar and may require repointing. It is imperative to use mortar which is softer than the masonry that will match the original in color and composition.

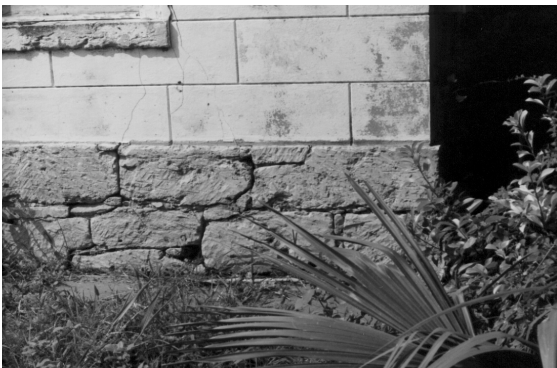
Repoint deteriorated masonry.

1. Retain and repair deteriorated masonry in the foundation on all sides of the building. Replace deteriorated mortar to match original in color and composition.
2. If the masonry or mortar is deteriorated, replace mortar, stone or brick to match original. The mortar should include sand which matches the color of existing sand, white portland cement and at least as much lime as cement.
3. If repair or replacement is cost prohibitive, remove deteriorated material and replace old stone or brick with new or salvaged stone or brick to match as closely as possible in color and proportion. If the stone was originally covered with a soft plaster, reapply a soft lime plaster to the surface of the stone. If the foundation is not visible from the street and is badly deteriorated, consider installing an alternative material such as concrete block. Re-plaster foundation if previously plastered.

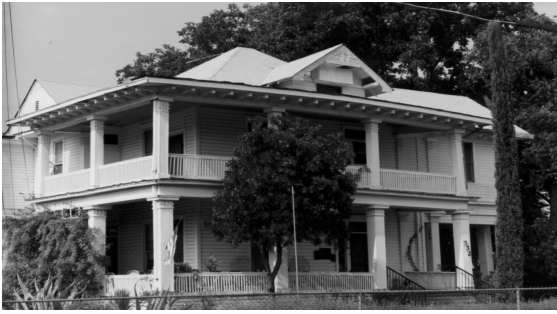
Many houses have horizontal wood siding.

Stucco, painted brick, board and batten and horizontal wood siding cover the houses of Government Hill. The majority of the frame houses retain their original siding but a few of the houses have been covered with synthetic sidings such as asphalt, asbestos, vinyl or aluminum and occasionally, stucco. It is important to retain the original siding and its appearance. Most of the siding profiles are still manufactured and available locally. These should be used for repairs or, if the dimension varies, original material might be relocated to the front facade and new material installed on less prominent facades. Many of the wood sidings have been on the houses for one hundred years and may well last another hundred if properly maintained and painted.

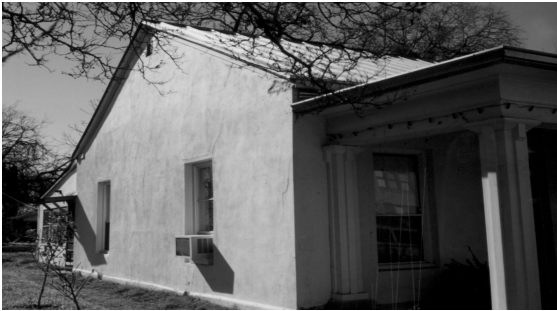
Portland cement plaster or stucco damages the stone underneath it.

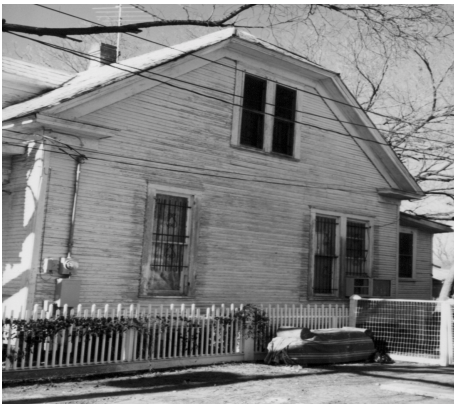
Deteriorated paint on wood siding should be properly removed during rehabilitation. The siding can then be primed and repainted for added life.

1. Retain and repair existing wood siding and trim. Remove any non-original siding material and repair the underlying original siding. Reinstall matching trim if missing or damaged.
2. If parts of the original siding and trim are deteriorated beyond repair or if trim is missing, replace with new wood to match.
3. If portions of the original siding are deteriorated beyond repair, consider installing non-matching siding on the less prominent facades. Salvaged original siding should be reinstalled on the more visible sides of the house. Alternative siding should have the same basic appearance as the original and may include newly milled wood, cement board siding with no "wood grain", or other composite board siding, again without "wood grain".

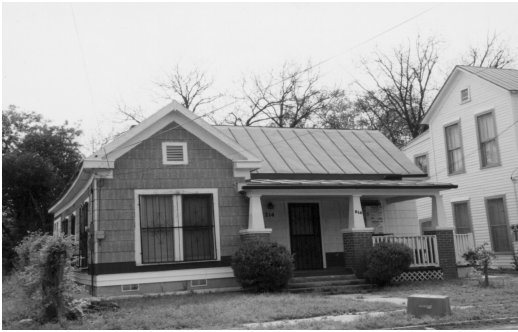
Existing synthetic siding could be removed and the wood siding beneath it could be restored.

1. Remove existing synthetic siding and repair original siding and trim underneath.
2. Keep existing synthetic siding if it is in good repair and that does not cover all original detail. Remove that material which covers the detail or reinstall trim and detail that has been removed. For example, reinstall corner boards that were removed when asbestos siding was installed.
3. Badly damaged synthetic siding or if it is cost prohibitive to restore the original siding, consider removing and replacing it with an alternative material of the same appearance. Alternative sidings might include cement board siding, or composite board siding, etc.

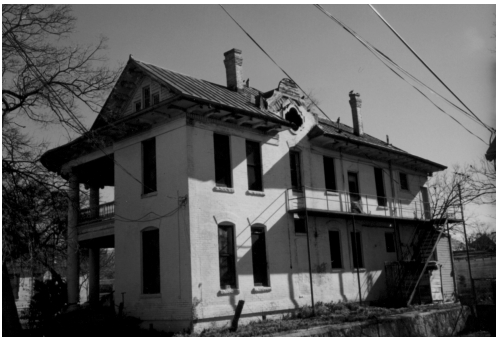
Painted brick surfaces can be cleaned and missing brick replaced to restore the wall.

1. Retain and repair the original brick of the house including all detailing. Clean paint from brick using the gentlest means possible, such as low pressure water wash or chemical stripper. Replace mortar to match the original in composition, color, and profile. Replace any missing or damaged brick with salvaged brick of the same color and proportion.
2. If painted surfaces are in basically sound condition and it is cost prohibitive to remove existing paint, consider making any necessary repairs or repointing of the masonry wall and repaint with a breathable latex paint.

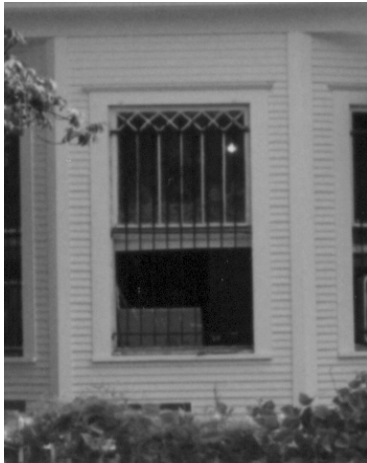
The multiple pieces of glass in a single sash are important to the character of this house.

The original windows of Government Hill houses are typically wood, double hung windows, operated with a rope and pulley system. Many of the houses have a simple one over one window pane arrangement while others have multiple pieces of glass in a single window sash. They play an important role in the character definition of the houses and the overall neighborhood.

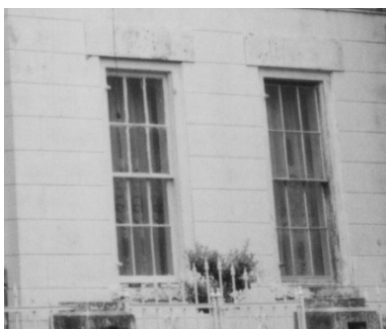
This 6 over 6 true divided light sash is important to the period of the house.

- If a divided light sash must be replaced and a true divided light sash is too costly to reproduce, a simple one light sash may be installed. No “snap-in” mullions or imitation dividers should be installed.

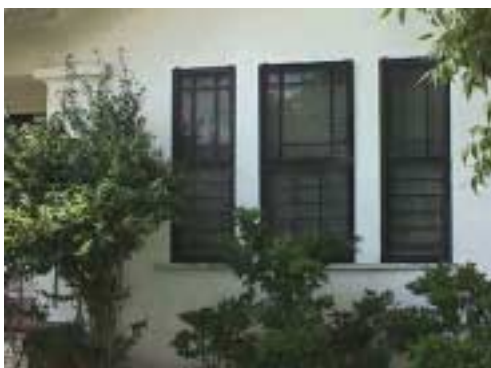
Screens were often custom made and wood details that add to character.

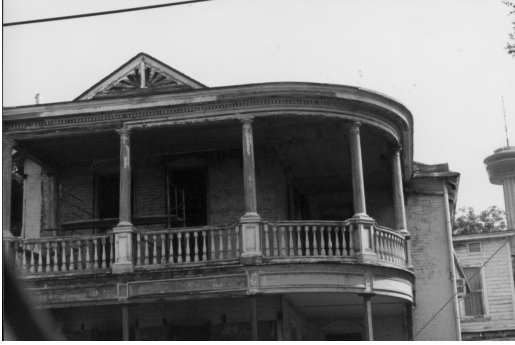
Porches are the most prominent feature on all the houses of Government Hill.

- Many of the porches have been altered and original columns removed and replaced with wrought iron columns or other inappropriate material and design, but the majority of the porches retain their character from elaborate gingerbread to bungalow brackets.

- Wood porch floors and column bases are usually the first things to fail on historic porches, but porch boards can be replaced with chemically treated boards of the same or similar dimension. Chemically treated No.1 yellow pine which has been back painted and properly primed works well.
- Frequently, the wood front steps and porch floor have been replaced with concrete, saving on maintenance, but it may also change the character of the house. Porch elevations should never be lowered to the ground so that the steps are reconfigured. Many of the materials can be salvaged and repairs completed using epoxy patching material, thus eliminating the replacement of original materials.

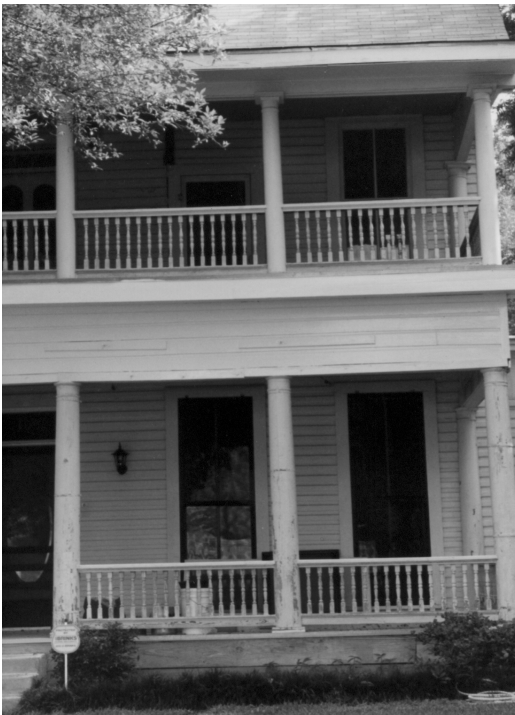
Retain and repair turned wood railings, columns and porch deck.

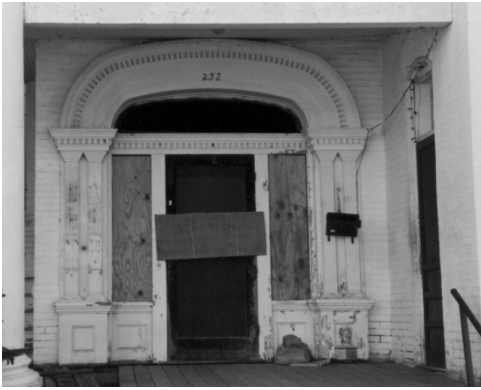
This detailed arched entrance with transom and side lights is important to the character of this house.

- It is important to maintain the multiple components of the entry doors including glass panels, transoms (the window above the door), sidelights and screen doors. Transoms have often been boarded up rather than repaired. In the case where synthetic siding has been installed, the transoms are frequently covered over. Uncovering a transom restores the strong vertical proportions of the windows and doors.

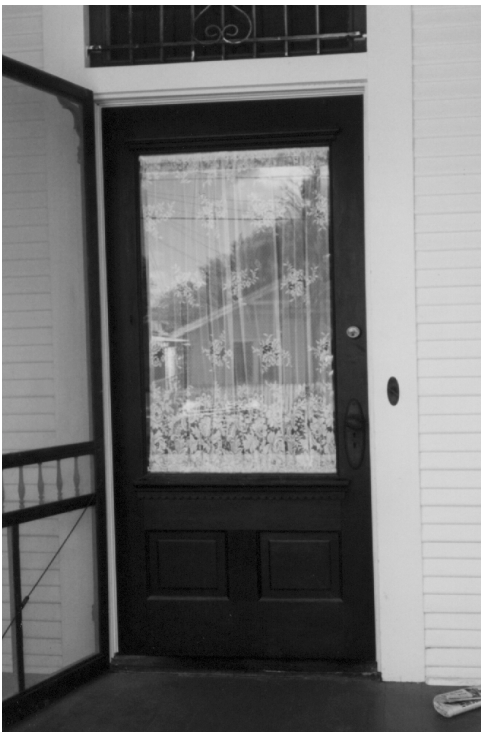
This is a typical historic front door with the upper glass panel, wood screen door and transom.

- Historic front doors usually have glass upper panels and should be repaired if at all possible.
- Where doors are damaged beyond repair or are completely missing, a salvaged door may be appropriate. A new entry with a simple but compatible design may be an acceptable solution.

- Another important feature is the wooden screen door, often with decorative inserts, which is present on most houses. Screen doors should be repaired when possible or replaced with new wooden screen doors which tend to be wider than contemporary, store-bought aluminum counterparts. If a full panel aluminum storm/screen door is the only affordable solution, a baked-on painted finish is more appropriate than a shiny aluminum “mill” finish.

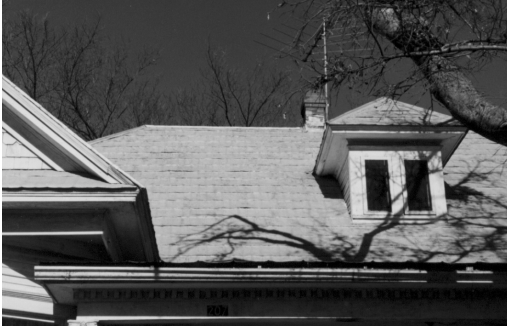
This house is covered in pressed metal "fish-scale" shingles.

Pressed metal shingles give a unique dimension to the roof of a structure and if maintained, have a life of 60 or more years. New metal shingles are still available in the same profile as historic shingles if replacements are needed. Another alternative is to salvage metal shingles and reinstall them on the primary facades, and use an alternative material, such as "V-crimp," on less visible roof surfaces.

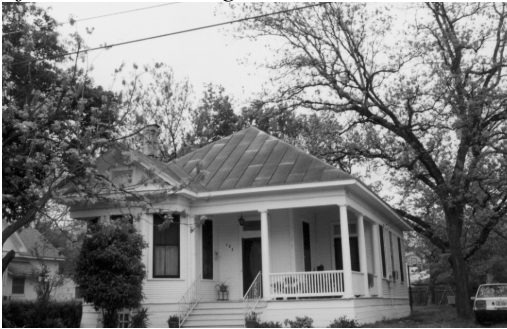
Standing seam metal roofs are common to the neighborhood and last for decades if properly maintained.

The Government Hill neighborhood is dominated by standing seam metal roofs with a few pressed metal shingles, a few wood shingles and of course composition shingle roofs. The standing seam metal roof adds a very distinctive vertical line to the roof of the house.

Standing seam metal was often an early replacement for wood shingles and was installed directly over the wood shingle. If the metal roofing were to be removed and replaced with an alternative material it must be noted that a solid wood deck should be installed prior to new shingles. The composition shingle is currently the most common replacement material but another replacement option is "V-crimp" metal which is cheaper but similar to the appearance of standing seam metal. Multiple chimneys and dormers are also prominent features which add character and date the house. Dormers and vents are often neglected and dormer windows broken, allowing birds to nest in attics and rain to enter. Dormers, chimneys and vents should be retained, repaired and new flashing installed if necessary.

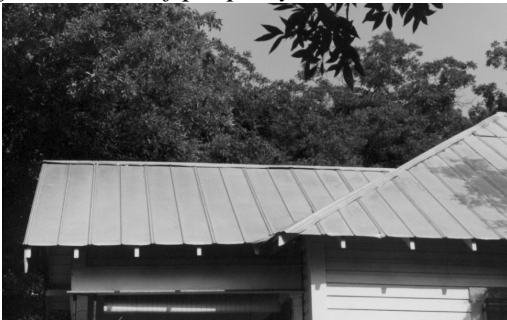
"V-crimp" metal roofing is an affordable alternative to composition shingle or a new standing seam roof.

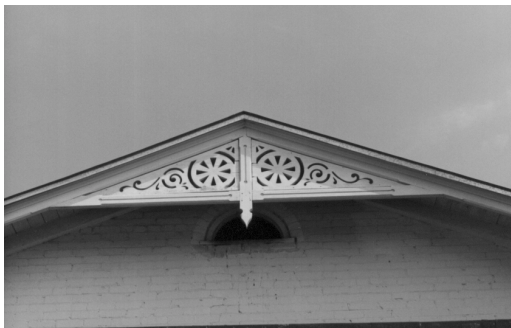
This scroll cut bargeboard decorates the gable end of this roof.

Roof edges and front facing gable ends are normally an area for decorative features on the houses of Government Hill. Gable ends frequently have shingled wall surfaces with decorative vents or windows and decorative barge boards. Frequently the triangle of a gable end is completed by a small portion of roofing which should be treated as roofing. Boxed eaves are sometimes accentuated with dentils and brackets or consoles. These features are important to the period of the houses whether Victorian, Classical or Craftsman. These details are also prone to damage and deterioration if a structure is not maintained.

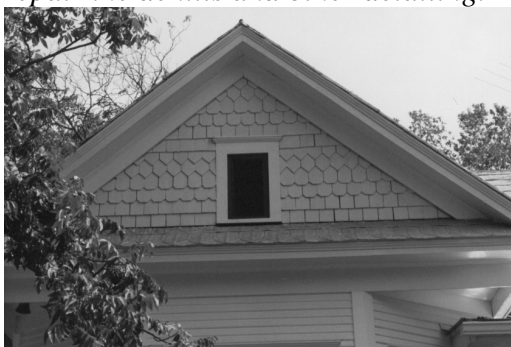
Boxed eaves, or overhang, are a typical detail in the neighborhood.
